IDEA & DATA EXCHANGE

CANONET 35mm CAMERA

FAULT – Requires Horizontal Range Finder Adjustment

Removal Of Top Cover Of Camera

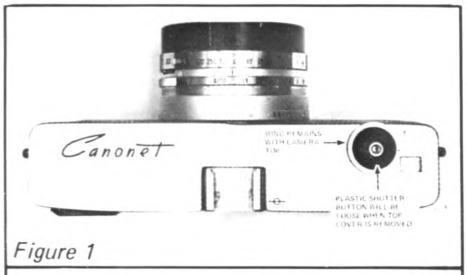
Figure 1

1. Top view of camera (Photo No. 1)
2. Front view of camera (Photo No. 2)
3. Remove three screws, one on each end of top, and one center rear. Lift off top. The knurled ring on top around plastic shutter release button remains with top cover as it is lifted off. Shutter button is now loose but its slotted underside seats onto shutter release mechanism of camera body. Above the shoulder of this button, this camera had two cloth dust rings. Remove button for safe keeping. (Photo No. 3).

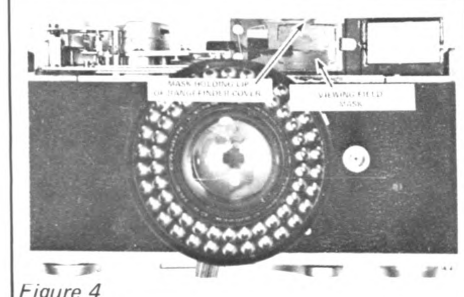
Figure 4

4. Reference photo of front view of camera with cover removed (Photo No. 4).
5. Reference photo of rear view of camera with cover removed (Photo No. 5).

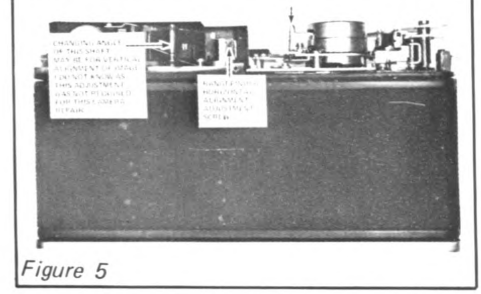
Figure 5

Note: This was only adjustment required on this camera. On studying camera, possible other adjustment to correct other faults may be accomplished by changing angle of secondary mirror stud (Photos No. 5 and No. 9).

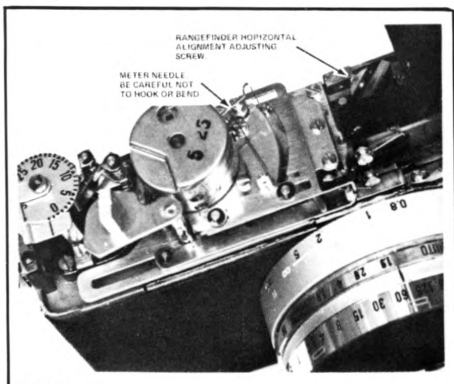
Figure 6

6. Angle reference photo of light meter, film counter side of camera with top cover removed (Photo No. 6).
7. Vertical reference photo of light meter, film counter side of camera with top cover removed (Photo No. 7).

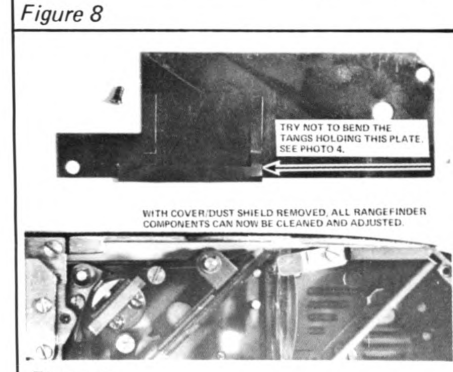
Figure 9

9. Further checking of rangefinder assembly for repair may be accomplished by removing two countersunk screws holding light shield/dust cover. Use caution so that you do not bend up the fragile metal plate held by two tangs to the cover. (Photo No. 9).
